# Service Facts

Desktop systems

BIOS/UEFI Recovery required after  
Windows Update

<b>Category:</b>	<b>DESKTOP</b>
<b>Version Number:</b>	<b>1.0</b>
<b>Version Date:</b>	<b>2025-06-18</b>
<b>Target Audience &amp; Document Classification:</b>	<b>Fujitsu Public</b>

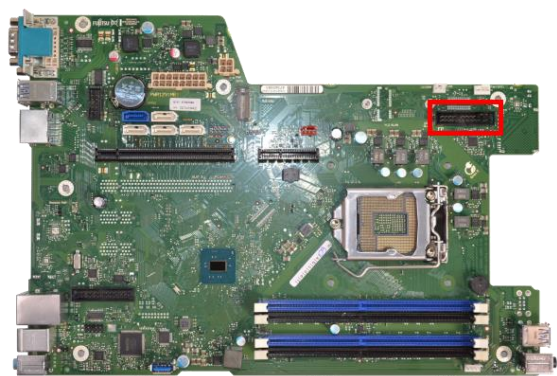
**CELSIUS J550 / ESPRIMO D556 / ESPRIMO D756 / ESPRIMO D956  
D3427-A1 / D3420-C1 / D3420-D1 / D3430-A1 / D3431-A1 / D3432-A1**

FRONTPANEL location (sample image):

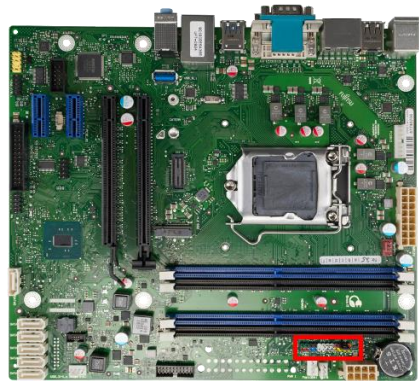
**CELSIUS W550  
D3417-A1 / D3417-A2**

FRONTPANEL location (sample image):

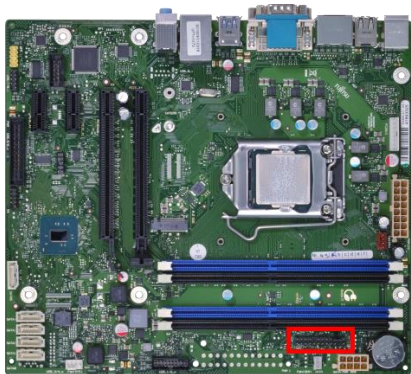
**ESPRIMO P756 / ESPRIMO P956  
D3401-A1 / D3402-A1**

FRONTPANEL location (sample image):

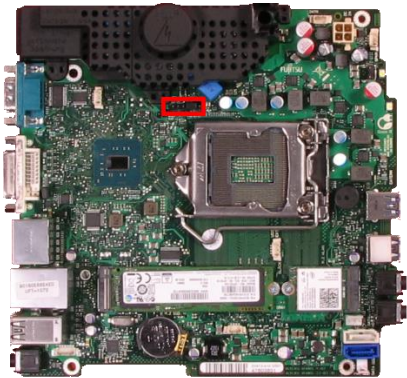
**ESPRIMO Q556 / ESPRIMO Q956**  
**D3403-A1 / D3403-B1 / D3413-A1**

FRONTPANEL location (sample image):

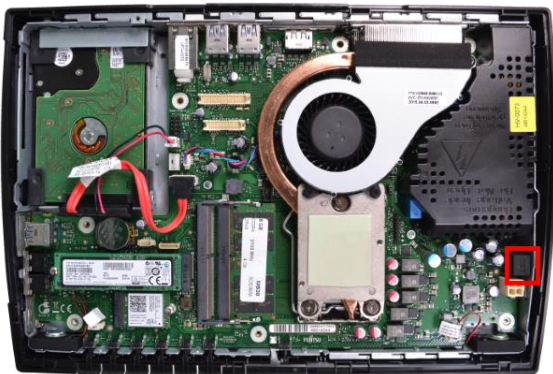
**ESPRIMO X956 / ESPRIMO X956/T**  
**D3444-A1**

Location of the Recovery Button:

In order to perform a BIOS/UEFI Recovery on this system you need to press the Recovery Button instead of setting a jumper.
